EFFLORESCENCE

What is efflorescence.

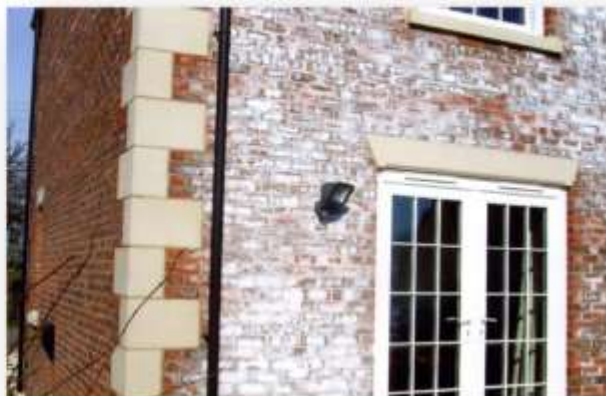
- *Design and detailing, e.g. lack of protection from sills and copings.*
- *Site practice, e.g. failure to protect unused bricks and newly built brickwork e.g. not affixing gutter downpipes, leaving cavities open to the elements.*
- *Site inadequacies -failure to observe design requirements e.g. inadequate formation of d.p.c detailing.*
- *Site exposure - specific building elevations can be more at risk than others by their position in relation to prevailing wind and rain conditions. Also particular areas of exposed brickwork, e.g. parapets.*
